DEPARTMENT OF TRANSPORTATION**DIVISION OF ENGINEERING SERVICES**

Contract #: 04-0120F4Cty: SF/ALA Rte: 80 PM: 13.2/13.9File #: 99.28**WELDING INSPECTION REPORT****Resident Engineer:**Pursell, Gary**Address:** 333 Burma Road**City:** Oakland, CA 94607**Report No:** WIR-016486**Date Inspected:** 23-Aug-2010**Project Name:** SAS Superstructure**OSM Arrival Time:** 700**Prime Contractor:** American Bridge/Fluor Enterprises, a JV**OSM Departure Time:** 1900**Contractor:** Zhenhua Port Machinery Company, Ltd (ZPMC) Chanxing Island**Location:** Shanghai, China

Bridge No: 34-0006**Component:** OBG Segments**Summary of Items Observed:**

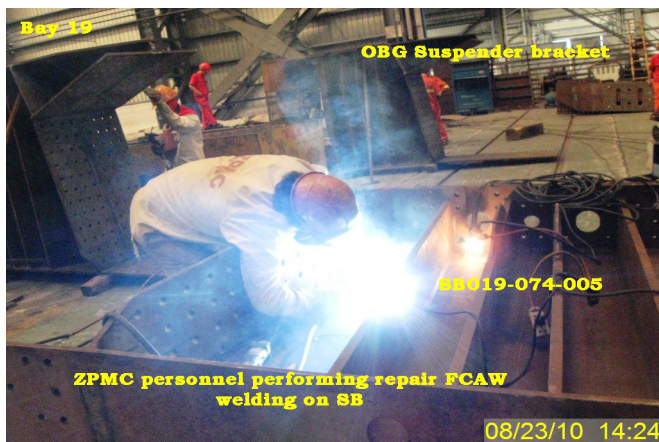
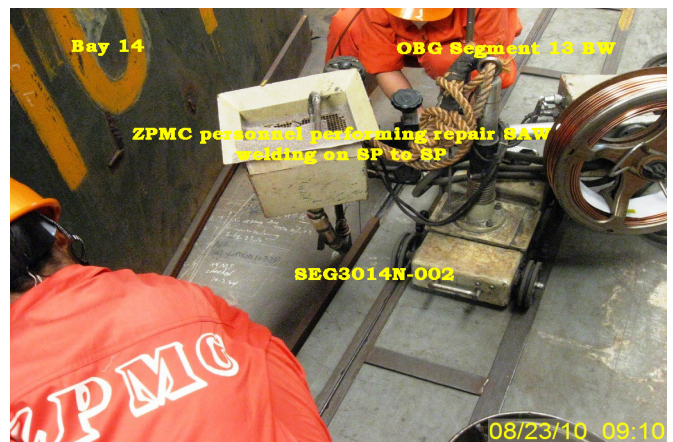
This QA inspector observed ZPMC qualified welding personnel identified as 062761 perform Flux Core Arc Welding (FCAW) repair welding on suspender bracket, weld joint identified as SB019-074-005. ZPMC QC is identified as Mr. Li Ming Yang. The welding parameters as measured using QC's calibrated instruments appeared to be in general compliance with WPS-345-FCAW-1G (1F)-Repair.

This QA inspector observed ZPMC qualified welding personnel identified as 062807 perform FCAW repair welding on suspender bracket, weld joint identified as SB020-082-007. ZPMC QC is identified as Mr. Li Ming Yang. The welding parameters as measured using QC's calibrated instruments appeared to be in general compliance with WPS-345-FCAW-2G (2F)-Repair. See the attached pictures
